IMÁGENES DEL RADAR METEOROLÓGICO

FECHA: 2018-11-09

EVENTO N: 1552

MAPA ACUMULADO RADAR

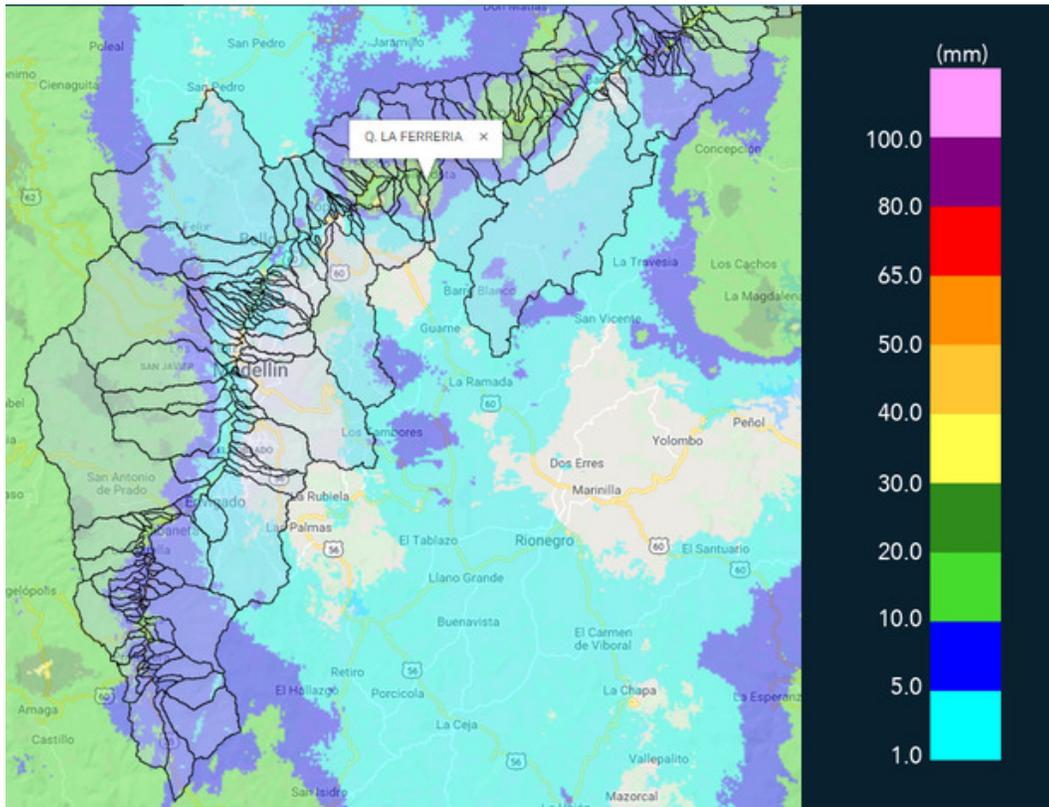
Los máximos acumulados de precipitación registrados por el radar se encuentran sobre las cuencas de Q. La Ferreira y aledañas en Girardota con valores entre 20 y 40 mm

(i) Mapa de acumulados de lluvia radar durante el evento

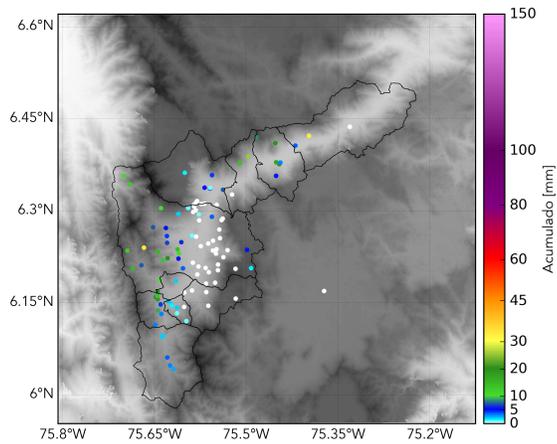
(j) Boletín Precipitación
